Ref: 5 Lapwing Lane, Christchurch

**RE: 5 LAPWING LANE, MT PLEASANT, CHRISTCHURCH**  
**NATURAL LOG HOME - PRELIMINARY STRUCTURAL ASSESSMENT**

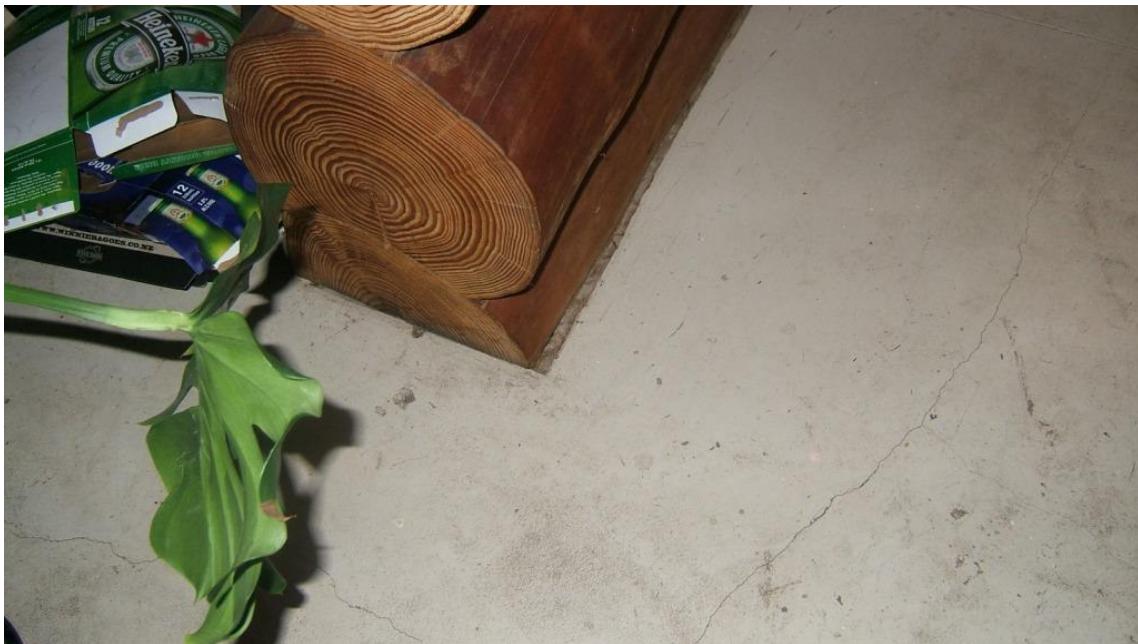
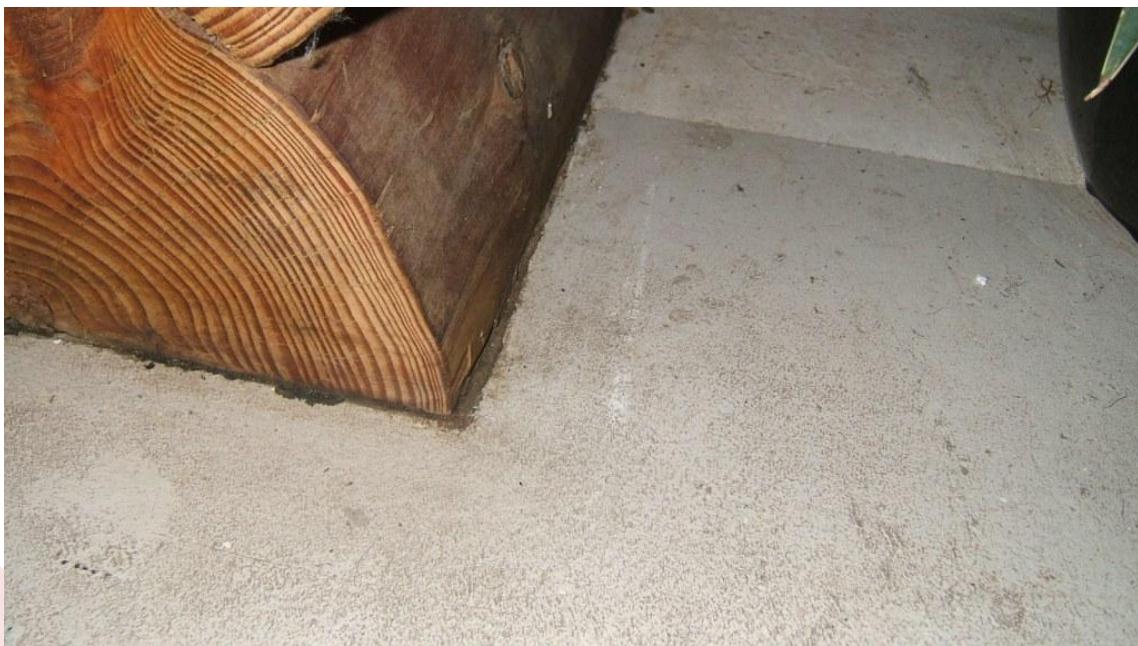
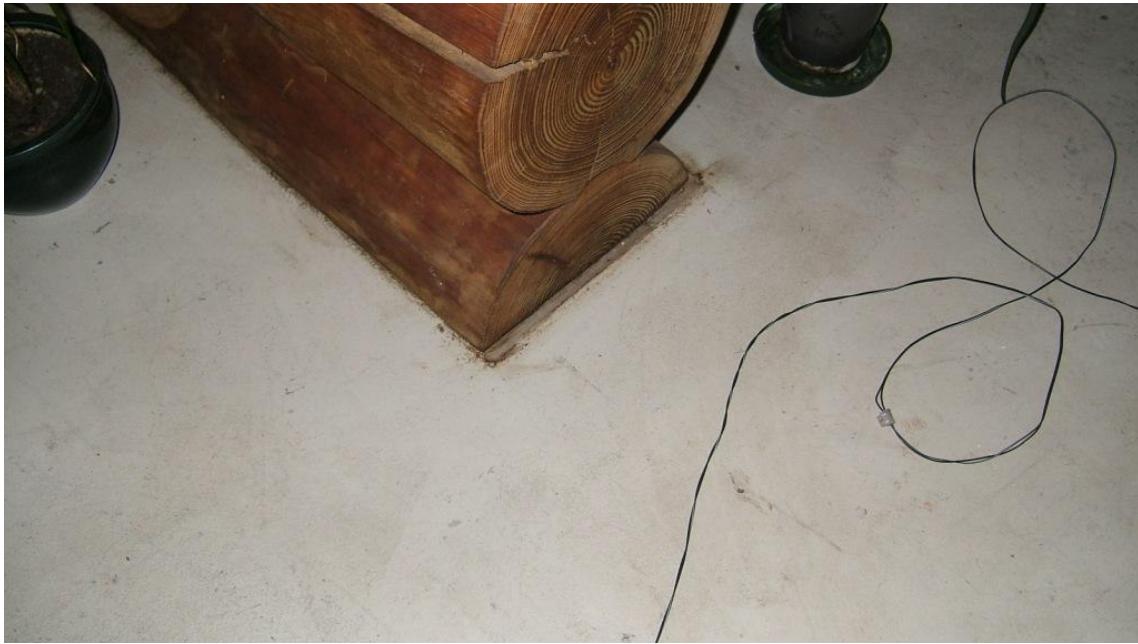
Damage to the log house was minor with little evidence of damage to the log elements. There has been minor lateral movement of some log walls (up to 20mm - this is especially evident in the internal log wall adjacent to the main lounge) otherwise the log walls appear to be in sound condition. Some extension of checks in logs was observed which is likely the release of internal tension. Refer to photos below.

Internal Log Wall Lateral Movement - 1

Internal Log Wall Lateral Movement - 2

Internal Log Wall Lateral Movement - 3

A detailed survey should be carried out to determine the extent of lateral movement, if any, of the log walls on the foundation slab. Log walls which have moved laterally should be jacked back into their correct location and re-fixed. This may also improve the separation of the kitchen joinery from the external log wall.

Following relocation of the log walls the hurricane rods should be correctly tightened. It is likely the loose rods enabled the log walls to move laterally and will also have contributed to the log movement evident in some areas.

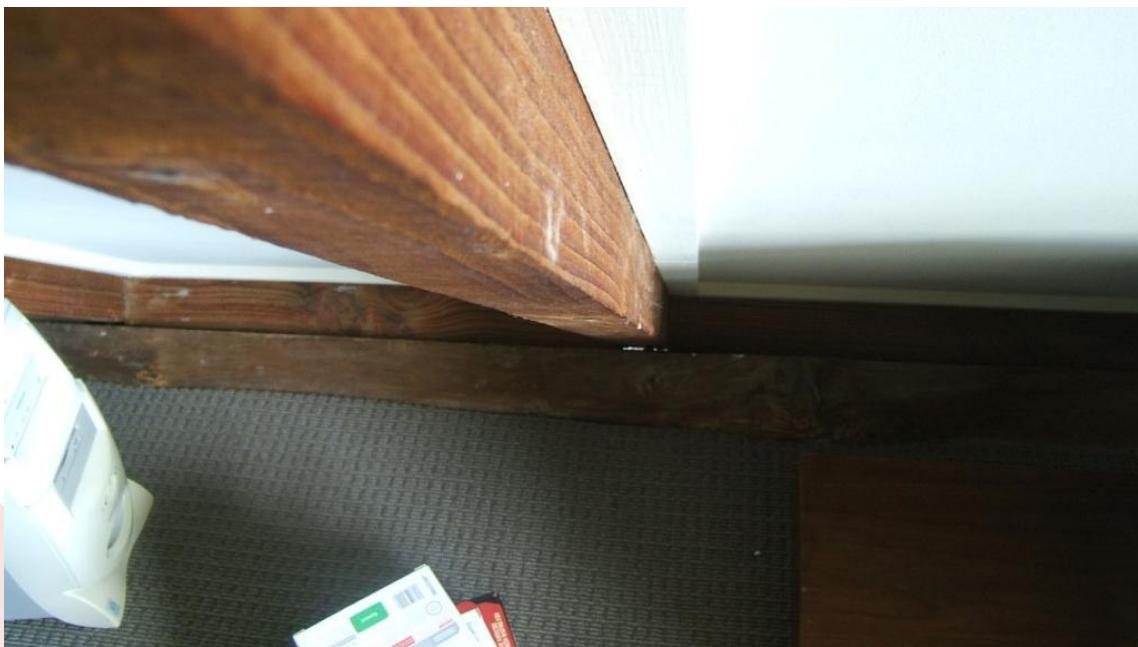
Fixings for the roof framing to the log walls at first floor level have separated slightly and there are minor indications of some log movement. Internal fixtures in the kitchen have moved slightly with the bench top separating from the log wall.

Rafter to Log Wall Fixing Separation (note daylight between rafter & log)

Fixings for the roof framing to log walls at first floor level should be repaired. This will likely require removal of the roof cladding to provide access to the fixings and enable repair. Cracked and broken Gib board linings to the internal timber framed walls should be removed, the timber framing checked and the linings replaced.

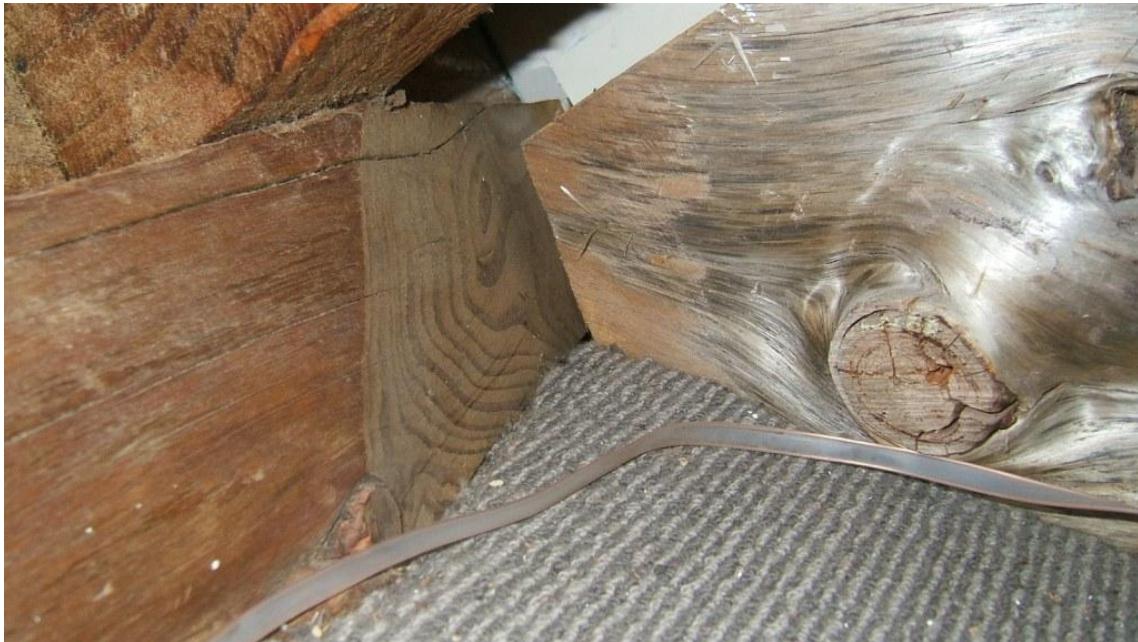
Rafter Fixing Separation & Log Movement

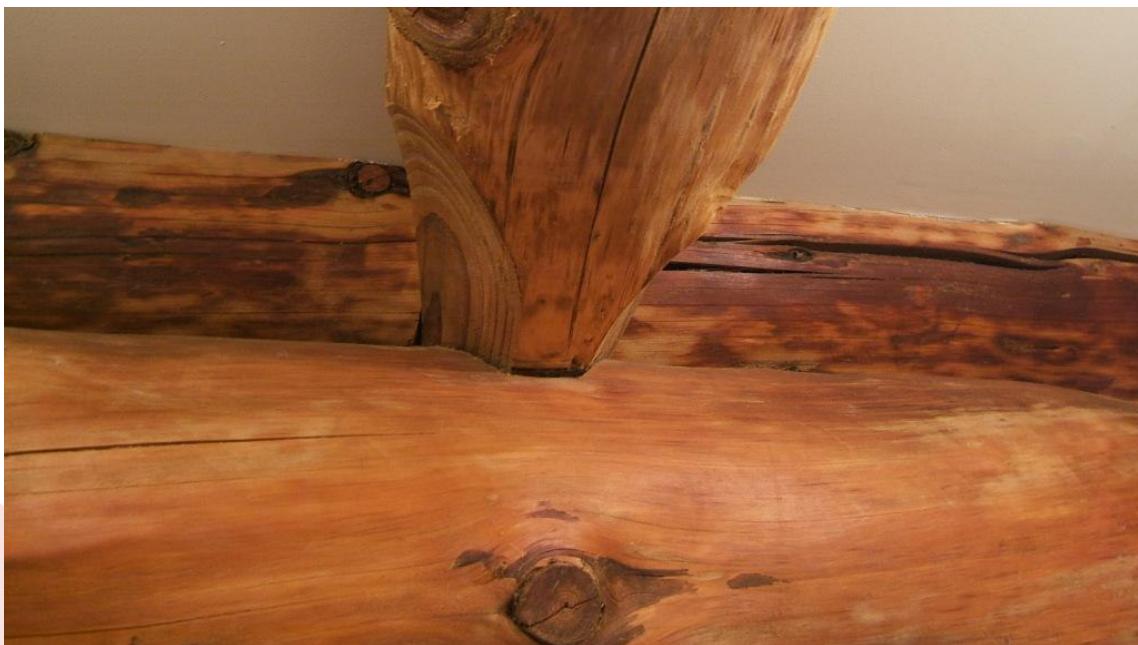
Log Bearer Movement at Seating

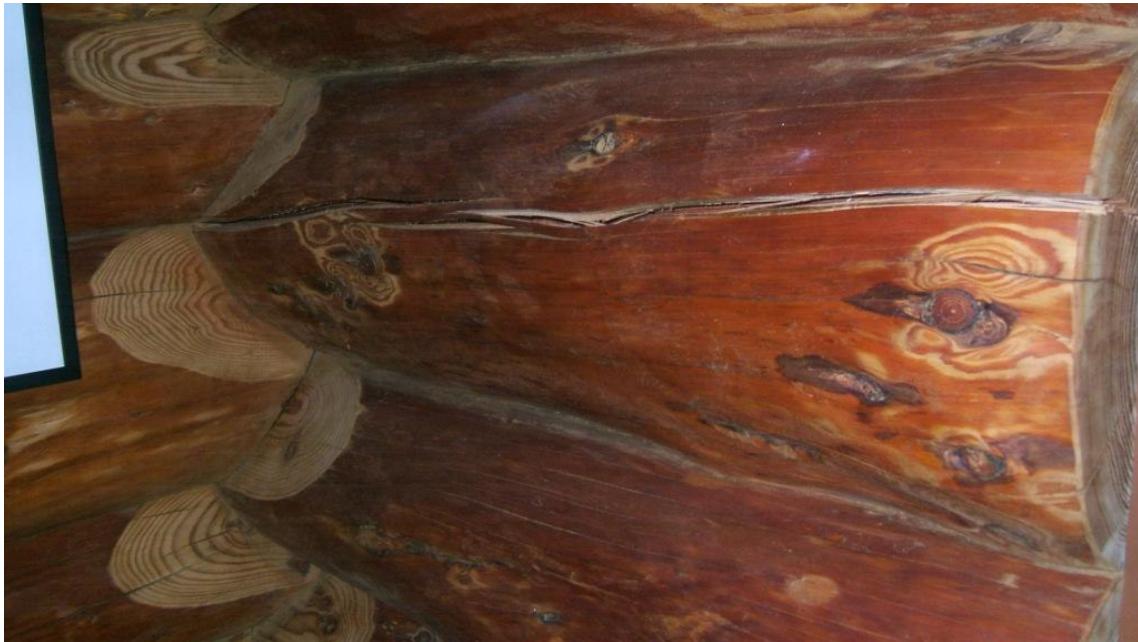
Log Checking - Extension

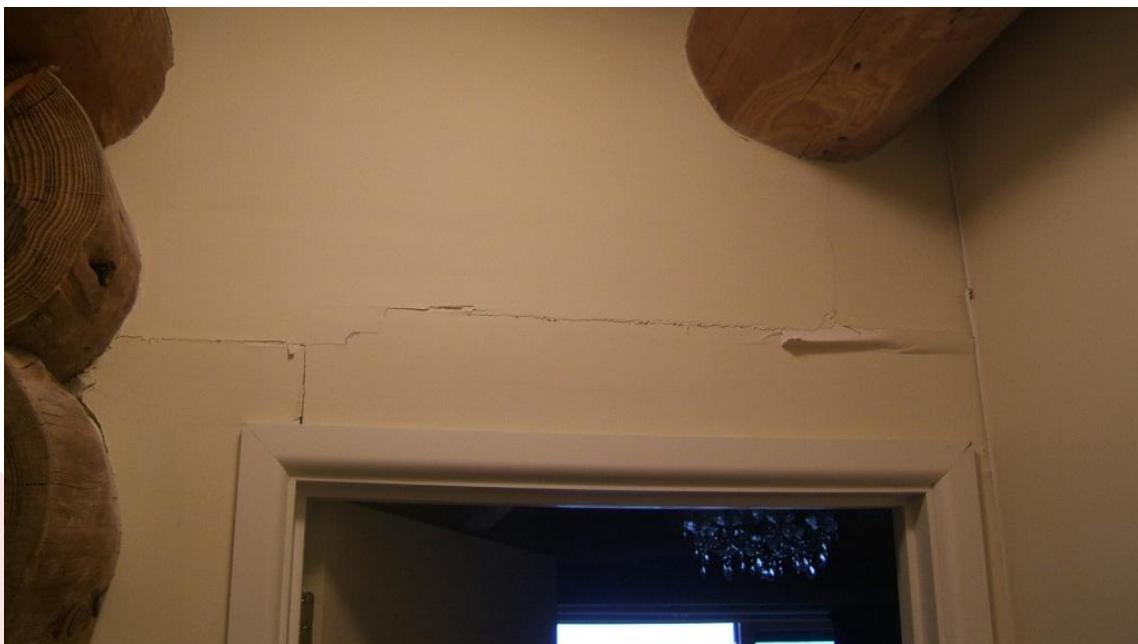
Internal timber framed walls with Gib board linings to the ground floor toilet area have suffered some significant damage however these walls are internal partitions. The first floor timber framed walls all appear to be in sound condition with no evidence of cracking typically expected at the corners of window & door opening.

Internal Gib Board Wall Damage
