LOG HOUSE PERFORMANCE IN THE 2016 KAIKOURA EARTHQUAKE

Andy Buchanan¹ and Daniel Moroder^{2,3}

ABSTRACT

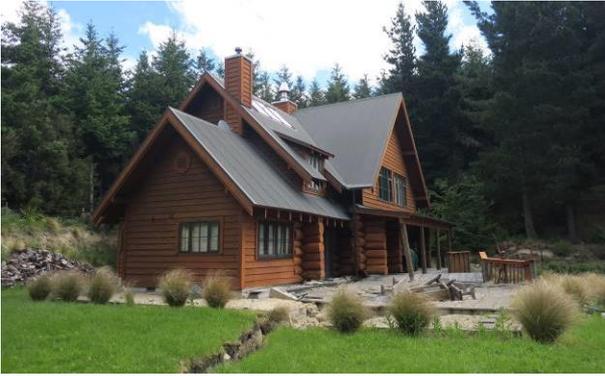
Figure 10: Two storey traditional log house with geotechnical damage.

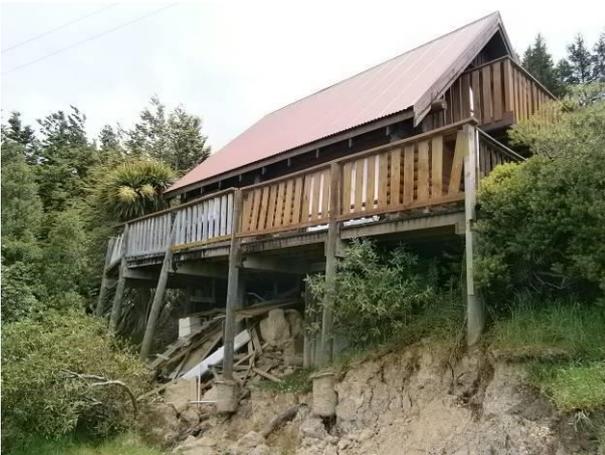
Figure 11: Two storey log house on slope with pole foundation with slope stability failure.

Many of the houses had geotechnical damage to the surrounding ground. A few houses lost support due to slope stability issues, as shown by the loss of support to the deck in Figure 11.

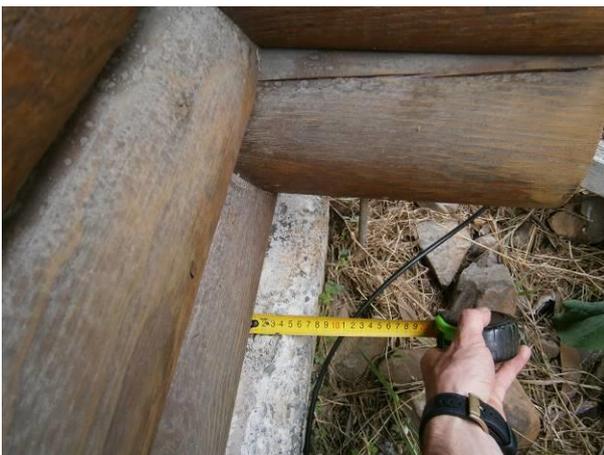
In a few houses with poor anchorage, the whole house slid horizontally on the foundations, by up to 100mm. Figure 15 shows local sliding of the house in Figure 3. Sometimes the sliding was at the top of the bottom half-log as shown in Figure 16. In a few exceptional cases, objects were trapped under the bottom log, showing that there had been considerable upward movement of the whole wall for a few moments during the earthquake as shown in Figure 17.

Figure 15: Horizontal sliding of the house.

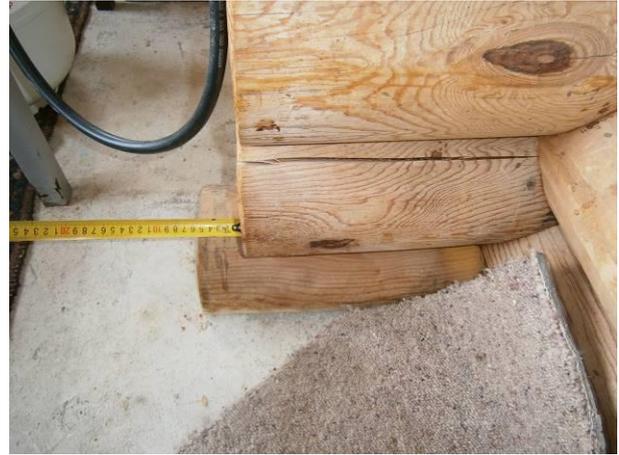
Figure 16: Sliding at the top of the bottom half-log.

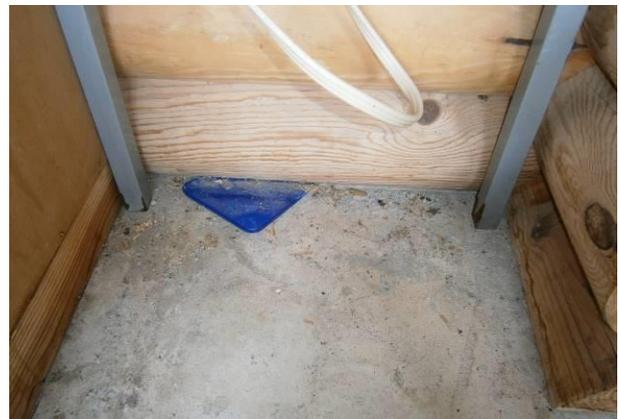
Figure 17: Ice-cream lid trapped under bottom log.

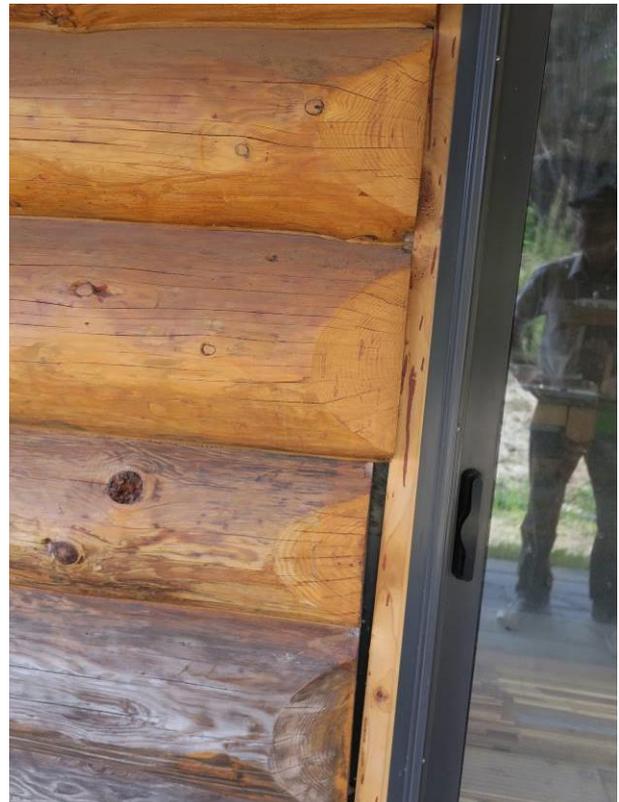
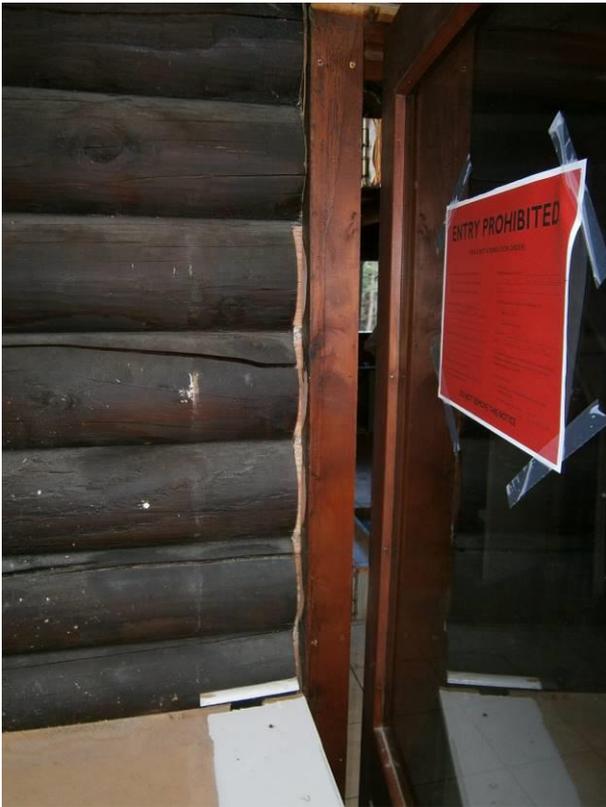
Most houses suffered damage through horizontal sliding between logs, to varying degrees. Sometimes this sliding was concentrated at one or two locations, as shown in Figures 18 and 19. More often the sliding was distributed between many logs as shown in Figures 20 and 21. In either case the sliding resulted in non-structural damage and some permanent distortion. Sliding was sometimes visible at the intersecting

Figure 18: Localized sliding of logs.

Figure 19: Localized sliding of logs.

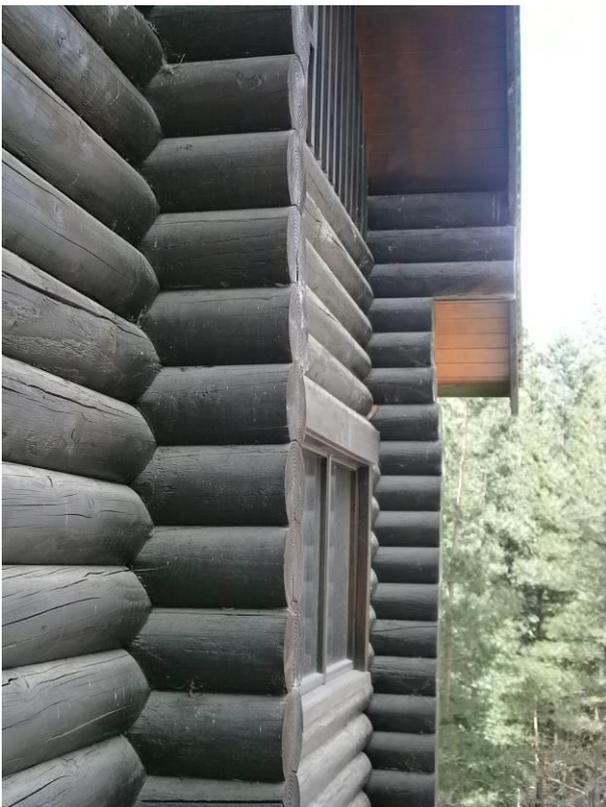
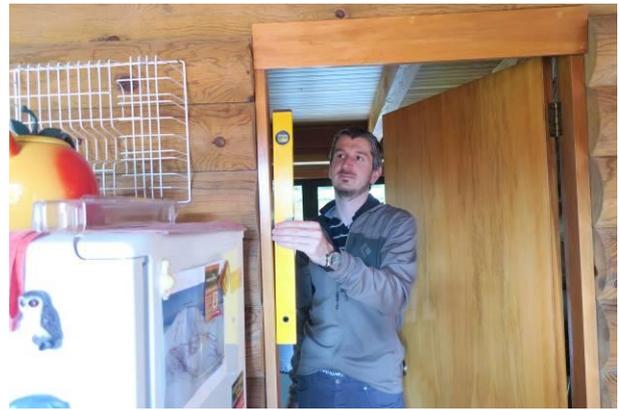
Figure 20: Sliding of logs resulting in residual drifts of the house.

Figure 21: Sliding of logs resulting in residual drifts of the house.

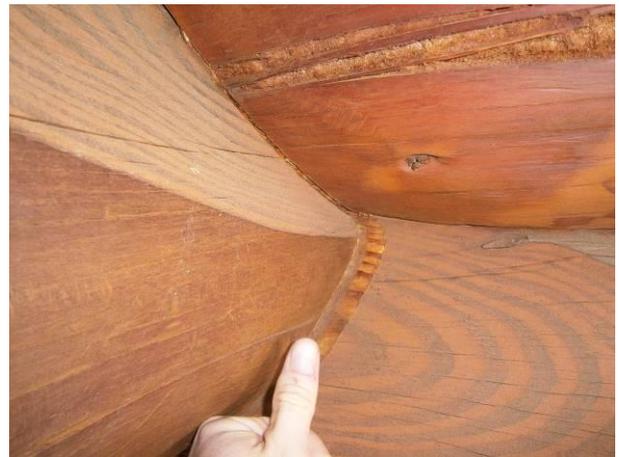
corner connections, especially for hand-hewn connections in large irregular logs as shown in Figure 22.

Figure 22: Sliding of the logs at corners.

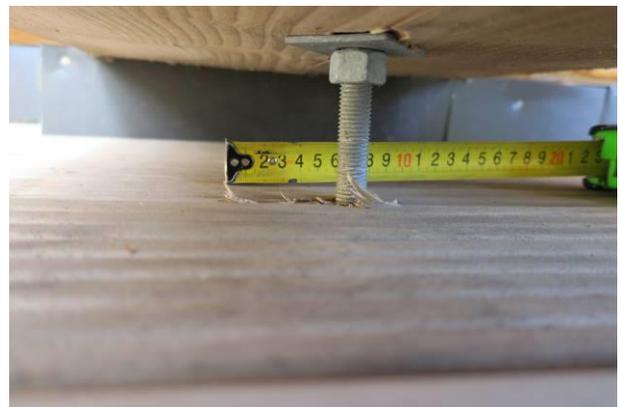
Figure 23 shows 60mm horizontal sliding where the bottom end of the tie-down rod was sitting on the top surface of timber decking.

Figure 23: Sliding of the logs measured at the vertical rod.

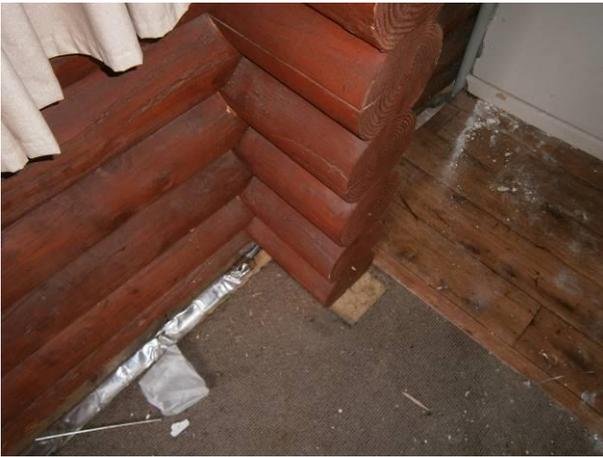
Figure 24 shows horizontal sliding above the lower suspended floor of the house in Figure 4. The large horizontal deformations in this house caused other structural damage including fracture of the post shown in Figure 25.

Figure 24: Sliding of the logs on suspended floor.

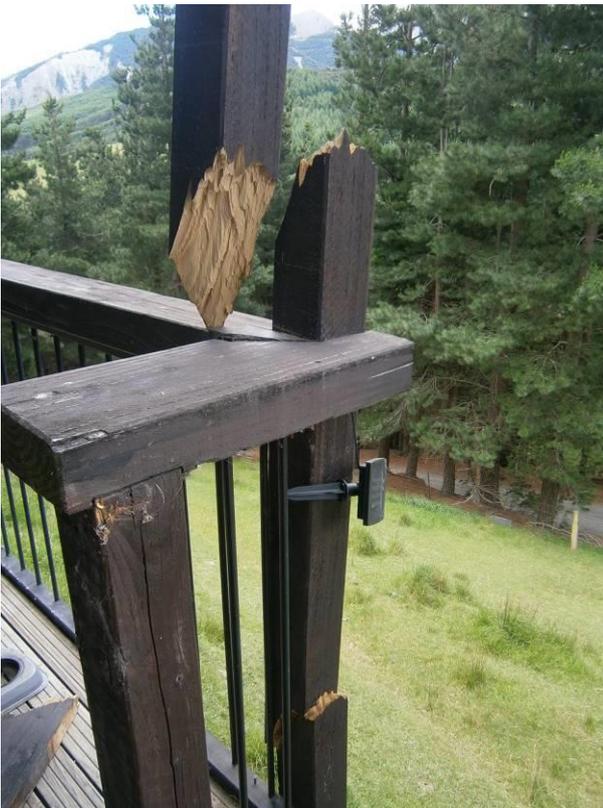
Figure 25: Fracture of veranda post due to excessive lateral movement.

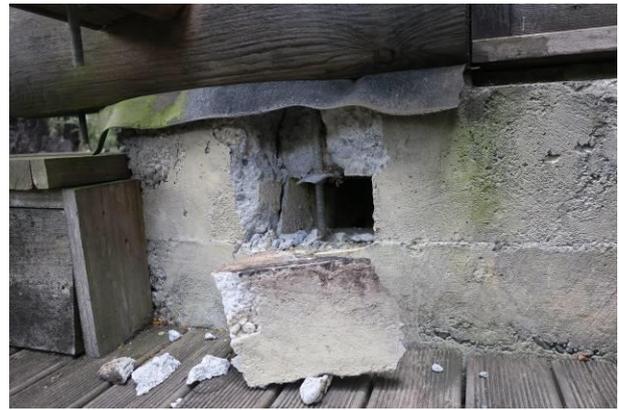
Figures 6 and 26 show damage to the unreinforced concrete foundation at a tie-down connection. Some rods were fractured by the tensile load as in Figure 27. Figures 28, 29 and 30 show visible damage at the bottom washers, where the damage is either a result of bending of the washer and some tensile yielding of the steel rods, usually accompanied by wood crushing or wood fracture. In some cases there was crushing of the bottom log as shown in Figure 31.

Figure 26: Damage to pocket in concrete foundation due to missing reinforcement.

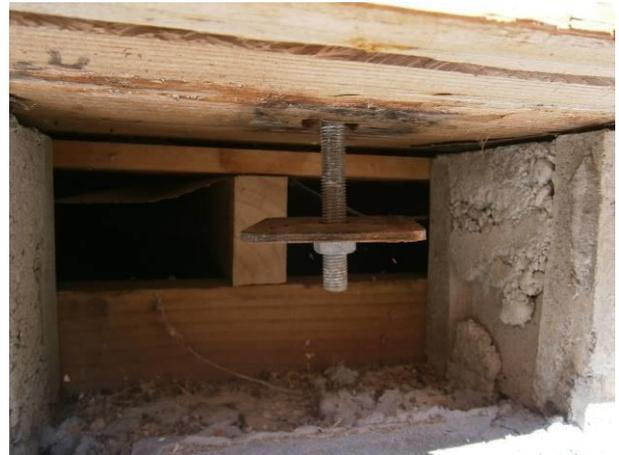
Figure 27: Fractured tie rod.

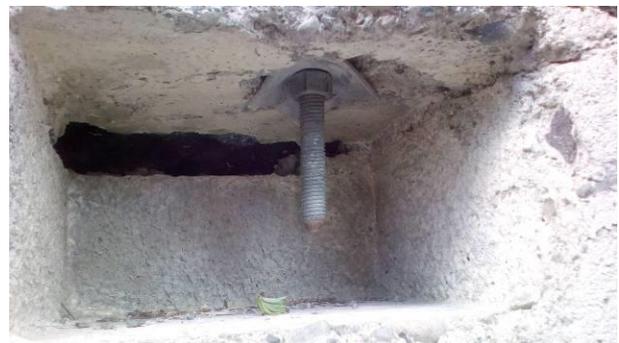
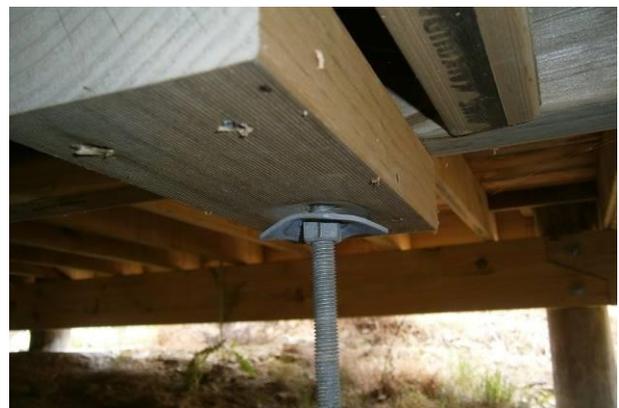
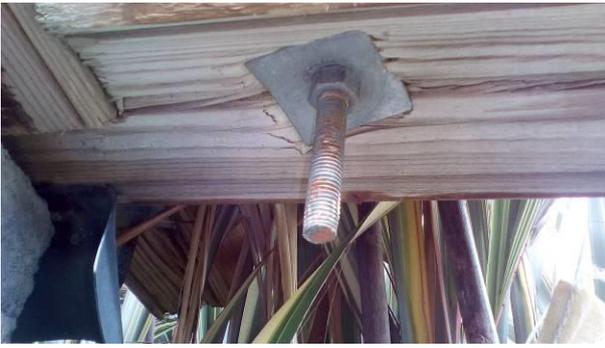
Figure 28: Bent washer in concrete pocket.

Figure 29: Bent washer and wood crushing in anchorage block.

Figure 30: Bent washer and wood crushing in bottom log.

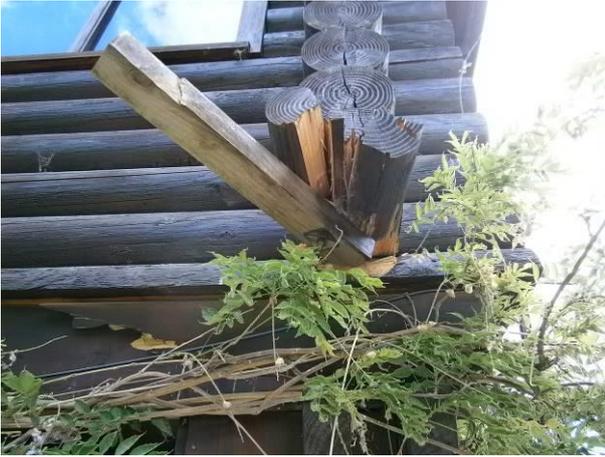
Figure 31: Crushing of bottom log.

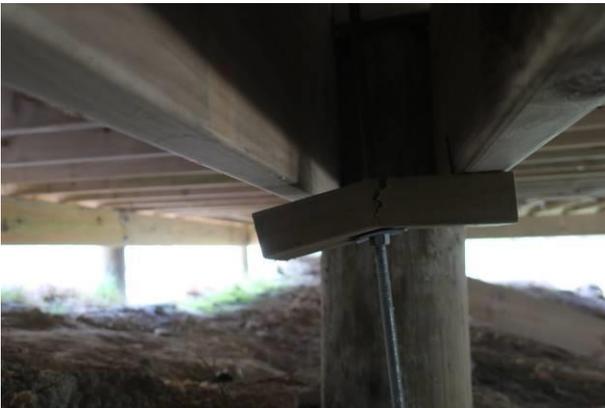
In houses with timber floors, there were some fractures of the short timber anchoring block between double joists as shown in Figure 32. Reinforcement provided by one owner after the earthquake is shown in Figure 33.

Figure 32: Failure of timber anchorage block.

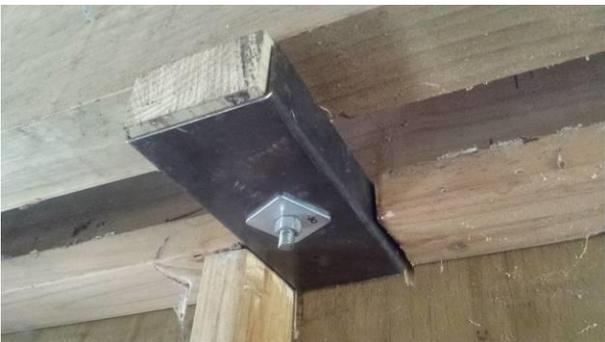
Figure 33: Reinforcement of timber anchorage with a steel profile.

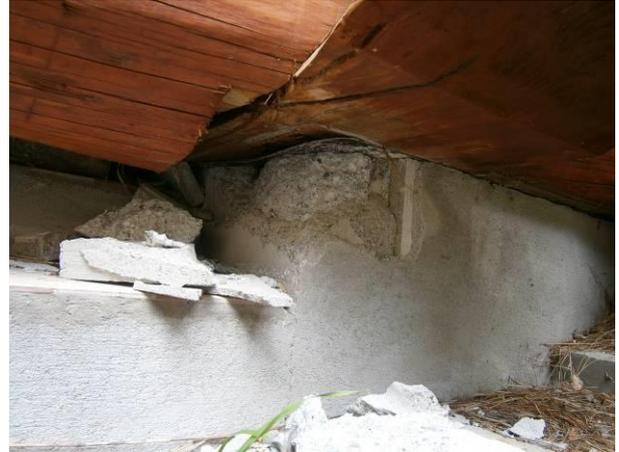
Most foundations performed very well, provided that the land remained stable. There were a few exceptions such as cracking off of the corner concrete shown in Figure 34.

Figure 34: Cracking and spalling of concrete due to large compression forces.

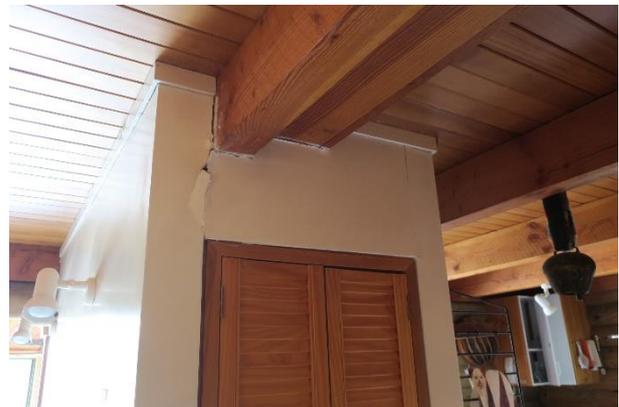
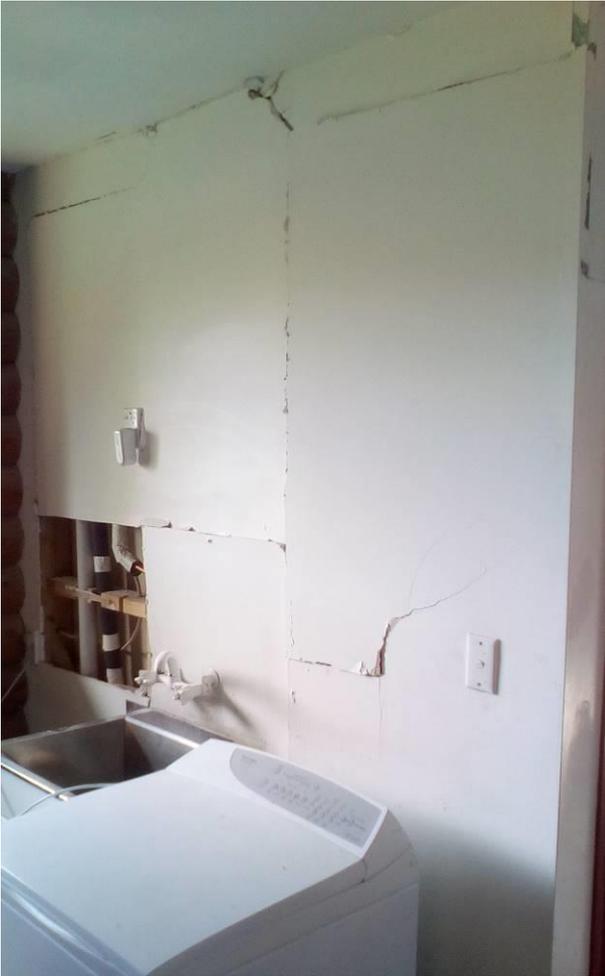
Almost all houses showed some non-structural damage to internal linings due to differential horizontal movements. Light timber framed walls at the same level as log walls could not accommodate the large lateral deformation of the log walls, resulting in cracked plasterboard lining especially around openings and at wall corners. Permanent lateral deformations resulted in obvious distortions and some doors which could not be closed. Typical cracking of gypsum plasterboard is shown in Figures 35 and 36.

Figure 35: Typical cracking of gypsum plasterboard.

Figure 36: Typical cracking of gypsum plasterboard.

Repairs to damaged linings and other non-structural damage will be required in almost every building.

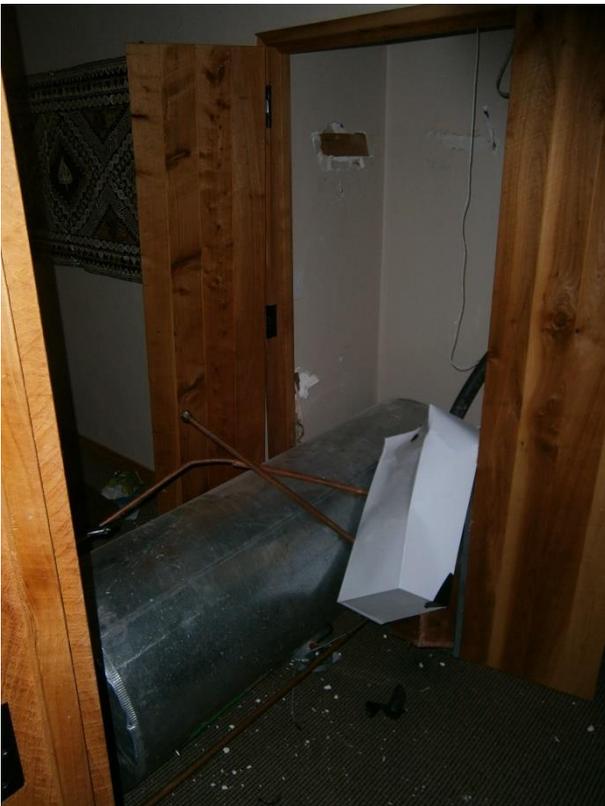
Some hot water cylinders with insufficient restraint fell over, causing additional damage to linings and plumbing, as shown in Figure 37.

Figure 37: Damage from insufficiently restrained water cylinder.

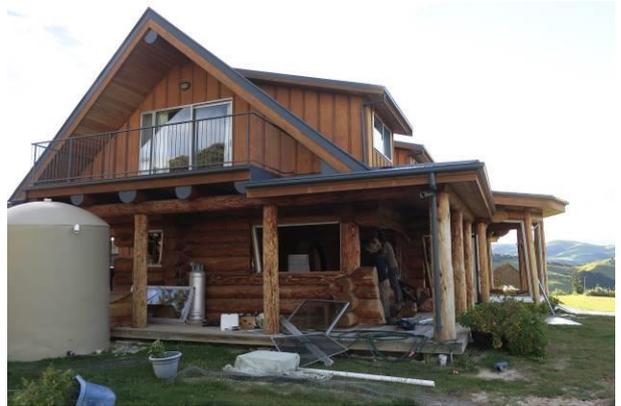
The authors were directed to one particular log house about half way between Mt Lyford and Waiau, which suffered extreme near-fault shaking, leading to extensive damage. This house is described separately to the others because of the higher level of damage. It is a new house, of large traditional log house construction on a concrete slab, shown in Figures 38 and 39. An indication of the extreme level of local shaking is provided by the rock on the lawn shown in Figure 40, which jumped to a new position over one metre away. The damage to this house is considered to be the result of exceptional ground movement rather than any major deficiencies in the design or construction. Local acceleration amplification due to the local topography, also known as the 'hill crest effect' [9], could have caused the increased shaking of the house.

Figure 39: Two storey traditional log house with visible residual drift.

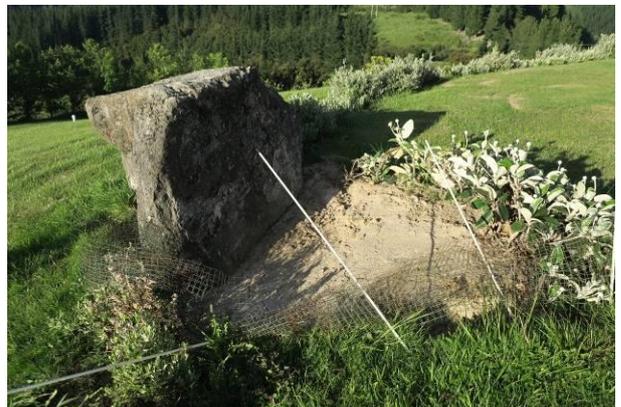
Figure 40: The rock close to the house was moved by about a meter by the earthquake.

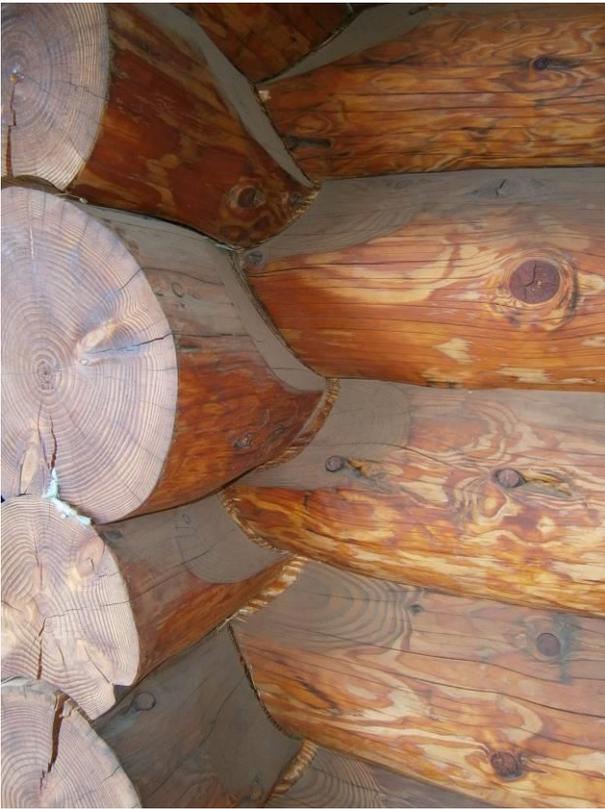
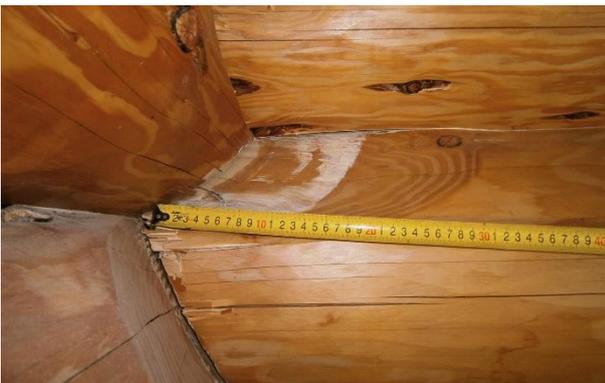
Figure 41: Permanent deformation in corner area.

Figure 42: Permanent deformation in corner area.

Permanent deformations from horizontal sliding between logs was much larger in this house than in houses at Mt Lyford, as shown in Figures 41 and 42. There was unusual movement around the circular steel frame of the front door shown in Figure 43 where there was upwards movement of logs due to the shape of the door frame. The picture trapped under the bottom log in Figure 44 shows that there was significant vertical movement of some log walls.

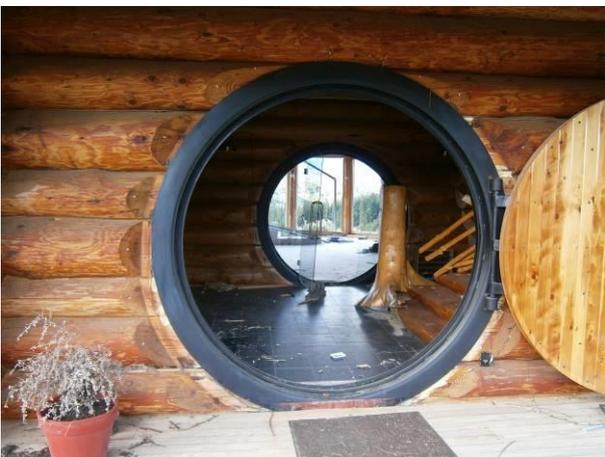
Figure 43: Large deformation around very stiff circular door frame.

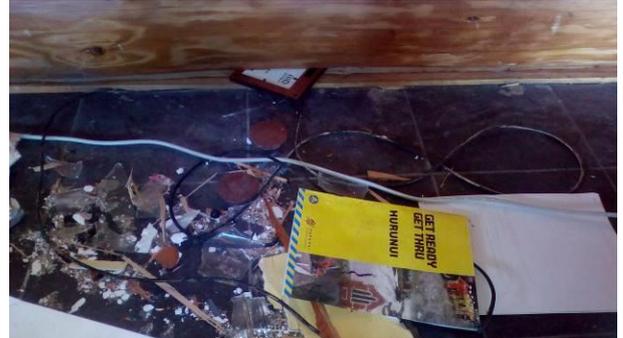
Figure 44: Trapped picture frame under sill log.

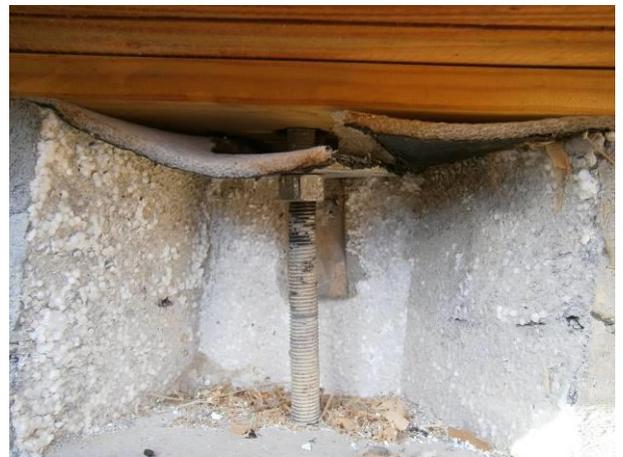
Figure 45 shows yielding of tensile tie rods. Significant damage occurred at the bottom log connection to the concrete slab, especially where there was a bottom half-log. A typical undamaged whole log is shown in Figure 46, whereas Figures 47, 48 and 49 show severe splitting of bottom half-logs in the transverse direction. This splitting was accentuated by the presence of tie rods (to resist uplift), dowels (to resist shear) and pre-cutting of logs at door and window opening to control shrinkage.

Figure 45: Yielding failure or fracture of tension rod.

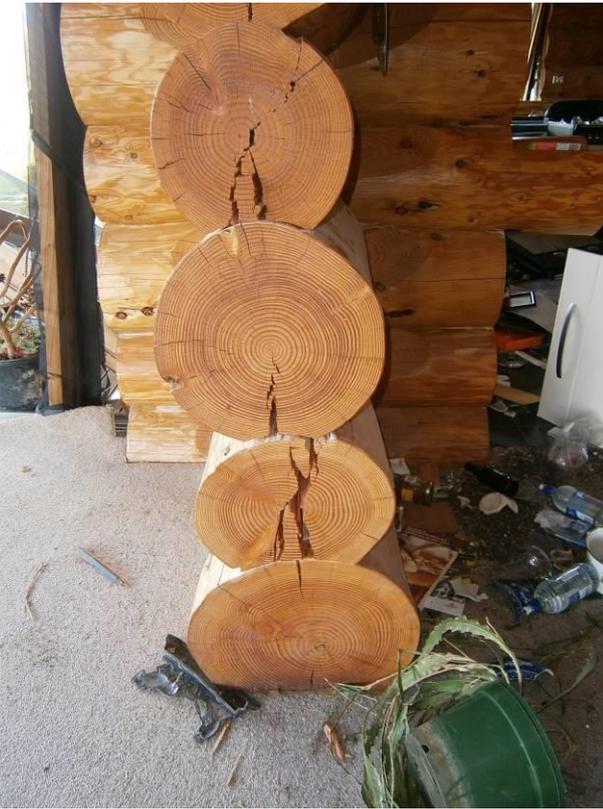
Figure 46: Initiation of splitting in logs, undamaged bottom log.

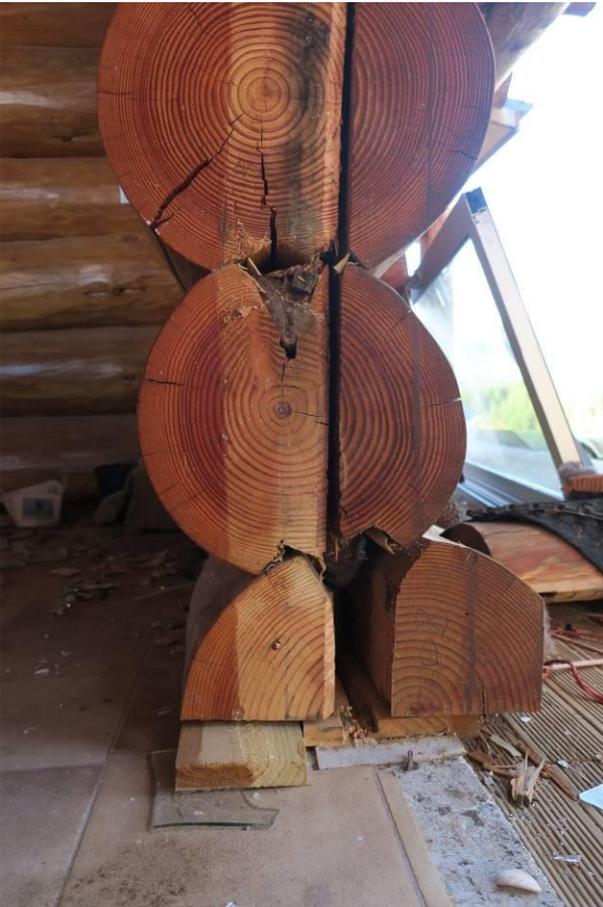
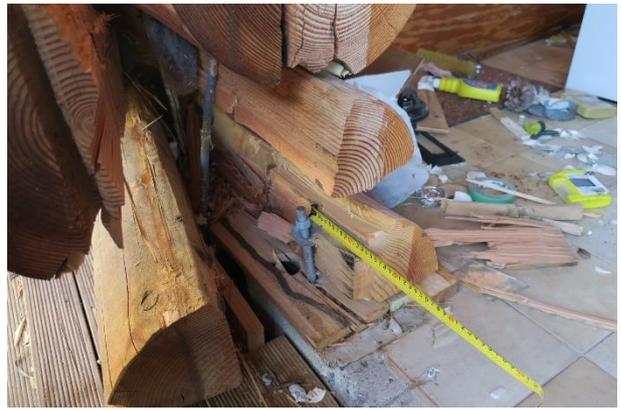
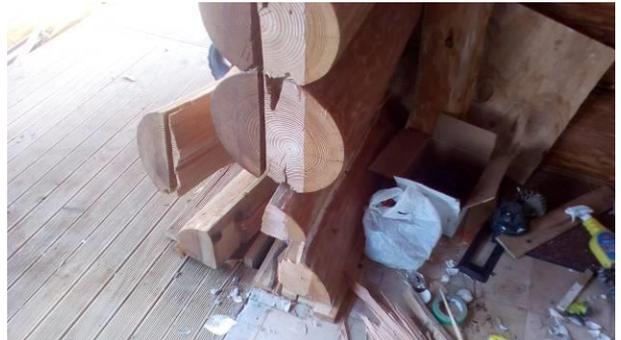
Figure 48: Splitting of logs weakened by tie rods and shear dowels.

Figure 49: Splitting of bottom log weakened by vertical slot at door frame.

Figure 47: Splitting of bottom log.

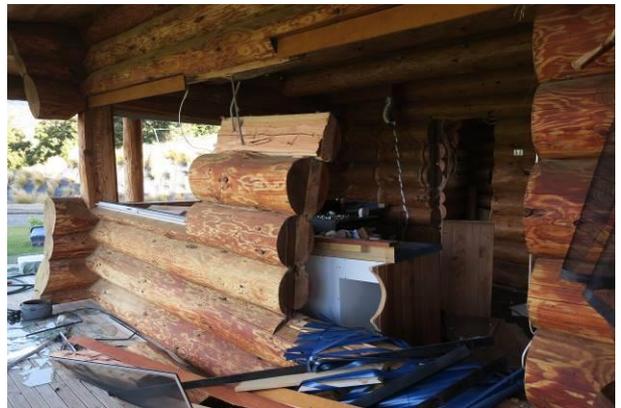
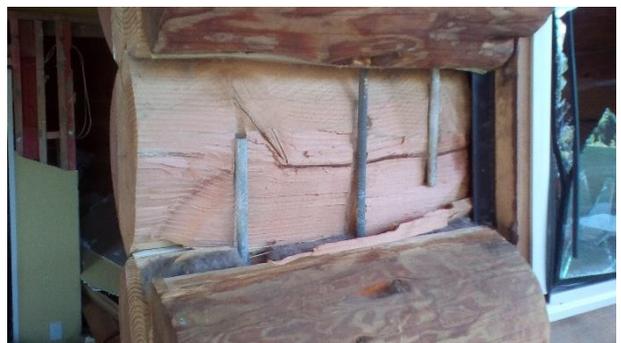
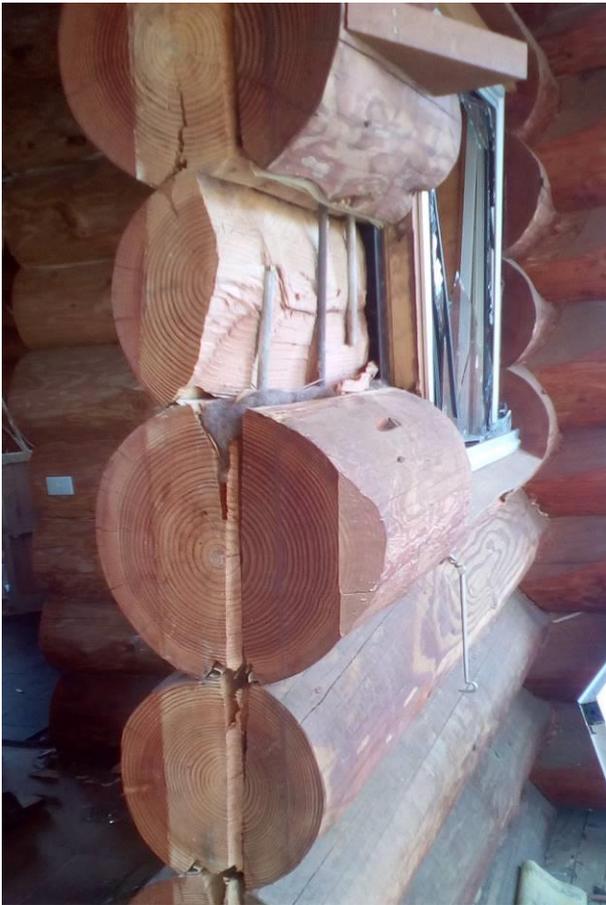
Walls with no cross logs were more badly affected, as shown in Figures 50, 51 and 52 where some logs have split in half exposing the tie-down rods and shear dowels.

Figure 50: Wall stability failure and splitting of logs.

Figure 51: Splitting of log.

Figure 52: Splitting of log due to weakening by dowels, tie rod and vertical slot at door frame.

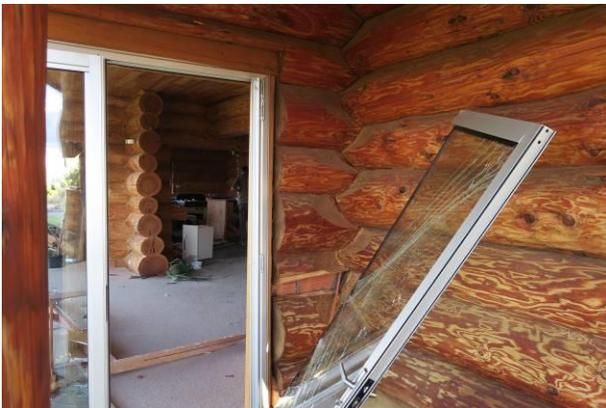
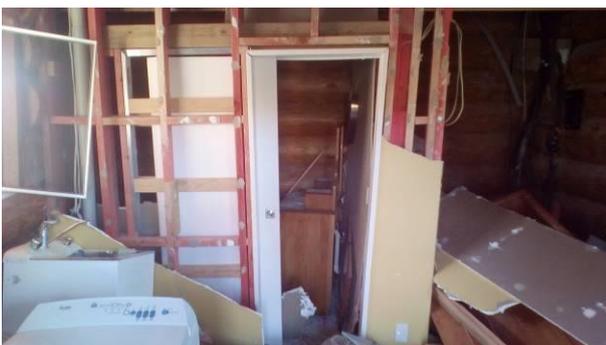
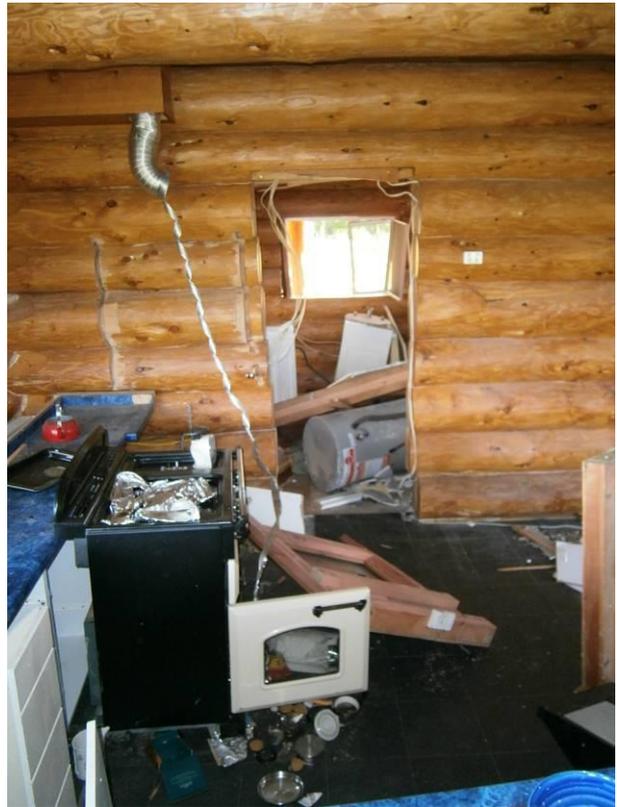
These large movements caused massive non-structural damage, as expected. Some typical downstairs damage is shown in Figures 53 and 54, and in Figure 55 which shows the kitchen and the hot water cylinder. Damage in the upper storey was much less, as shown in Figure 56.

Figure 55: Typical damage from falling or sliding of heavy objects.

Figure 53: Typical damage to doors and windows due to large horizontal deformation.

Figure 54: Typical damage to light timber framing walls lined with plasterboard.

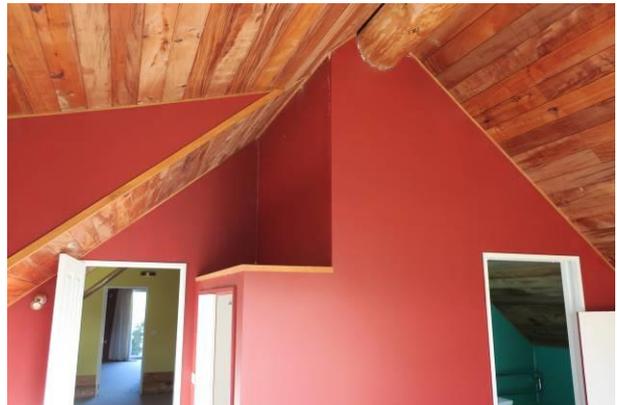
Figure 56: Damage in the upper storey was very limited.
