LOG HOUSE PERFORMANCE IN THE 2016 KAIKOURA EARTHQUAKE

Andy Buchanan¹ and Daniel Moroder^{2,3}

ABSTRACT

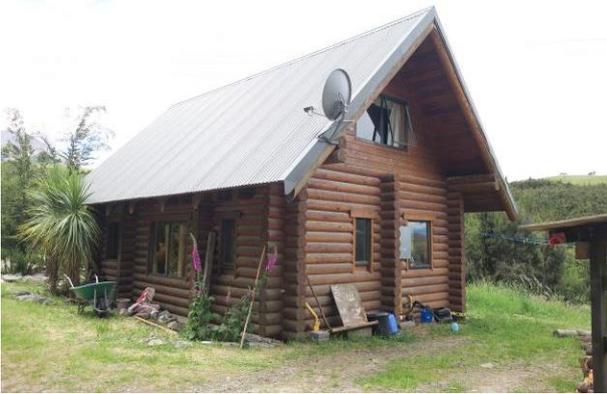
Figure 3: Two storey log house with slab on grade foundation.

In a few houses with poor anchorage, the whole house slid horizontally on the foundations, by up to 100mm. Figure 15 shows local sliding of the house in Figure 3. Sometimes the sliding was at the top of the bottom half-log as shown in Figure 16. In a few exceptional cases, objects were trapped under the bottom log, showing that there had been considerable upward movement of the whole wall for a few moments during the earthquake as shown in Figure 17.

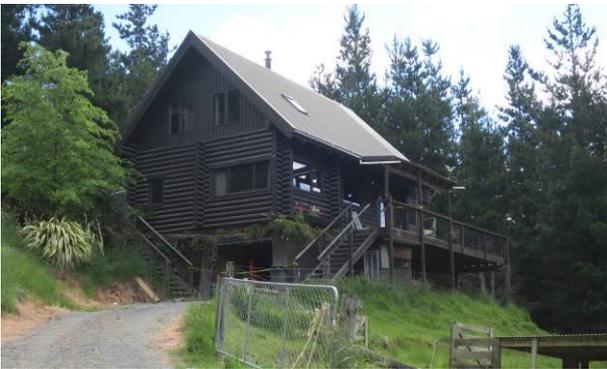
Figure 4: Two storey log house on slope with pole foundation.

Figure 24 shows horizontal sliding above the lower suspended floor of the house in Figure 4. The large horizontal deformations in this house caused other structural damage including fracture of the post shown in Figure 25.

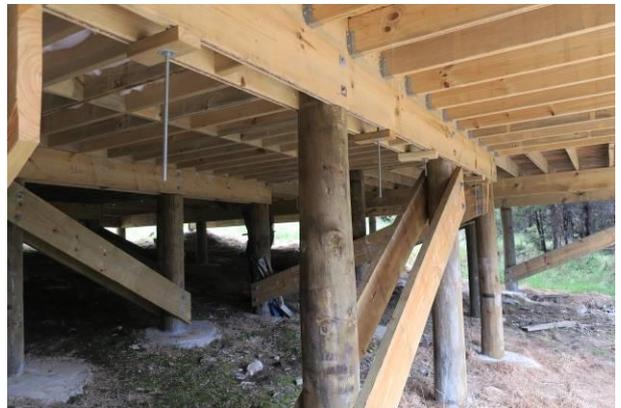
Figure 8: Pole supports with diagonal sub-floor bracing.

Lateral loads below timber ground floors are usually resisted by the cantilever action of short braced piles or by diagonal timber bracing between longer timber poles. No serious damage was observed in the sub-floor bracing of any houses (Figure 8).
